# MSP430F13x/14x/14x1 Device Erratasheet

## Current Version

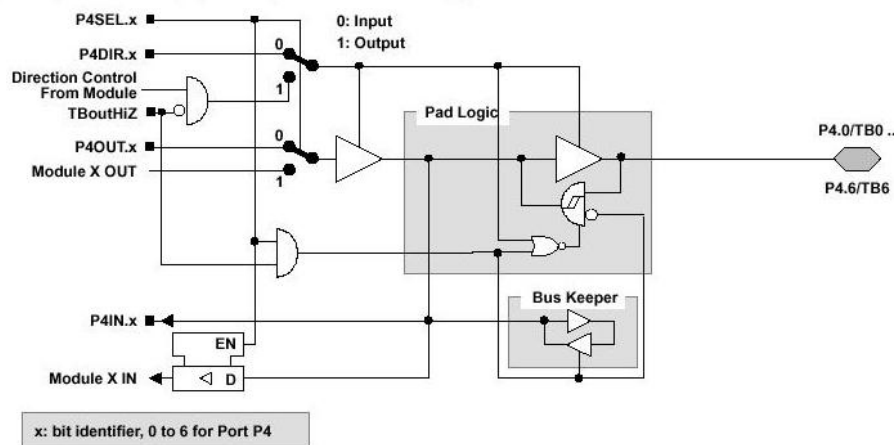
### Port function as specified:

port P4, P4.0 to P4.6, input/output with Schmitt-trigger

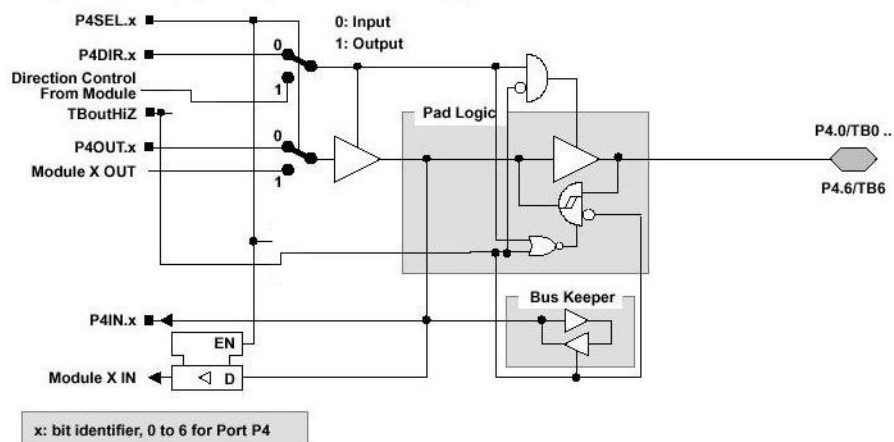
### Port realization with TB3 bug:

Incorrect tristate function of Ports P4.0/TB0 ... P4.6/TB6 (TBoutHiZ control).

If TBoutHiZ is set to 'high' all ports P4.0/TB0 ... P4.6/TB6 are set to tristate independent of the P4SEL.x control signals. This means a port P4.x is switched to tristate with TBoutHiZ even if it is not selected for TimerB function.

In addition the ports P4.0/TB0 ... P4.6/TB6 are switched to tristate with TBoutHiZ even if the port direction (direction control from module) is set to input. This is in accordance with the spec description, but nevertheless is an unexpected behavior.

port P4, P4.0 to P4.6, input/output with Schmitt-trigger

No workaround.
