Stellaris® LM3S9B92 RevB1 Errata

This document contains known errata at the time of publication for the Stellaris LM3S9B92 microcontroller. The table below summarizes the errata and lists the affected revisions. See the data sheet for more details.

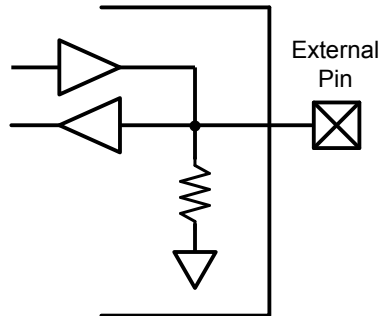
Figure 1. Internal Structure of PB0 and PB1

Regardless of their configuration, PB0 and PB1 have an internal pull-down resistance. The internal structure of these pins is shown in Figure 1 on page 15.

When either of these pins is configured as an input, the external circuit must provide enough drive strength to over-drive the internal pull-down and achieve the necessary V_{IH} voltage level. Analysis is ongoing to determine what value external resistors should have.

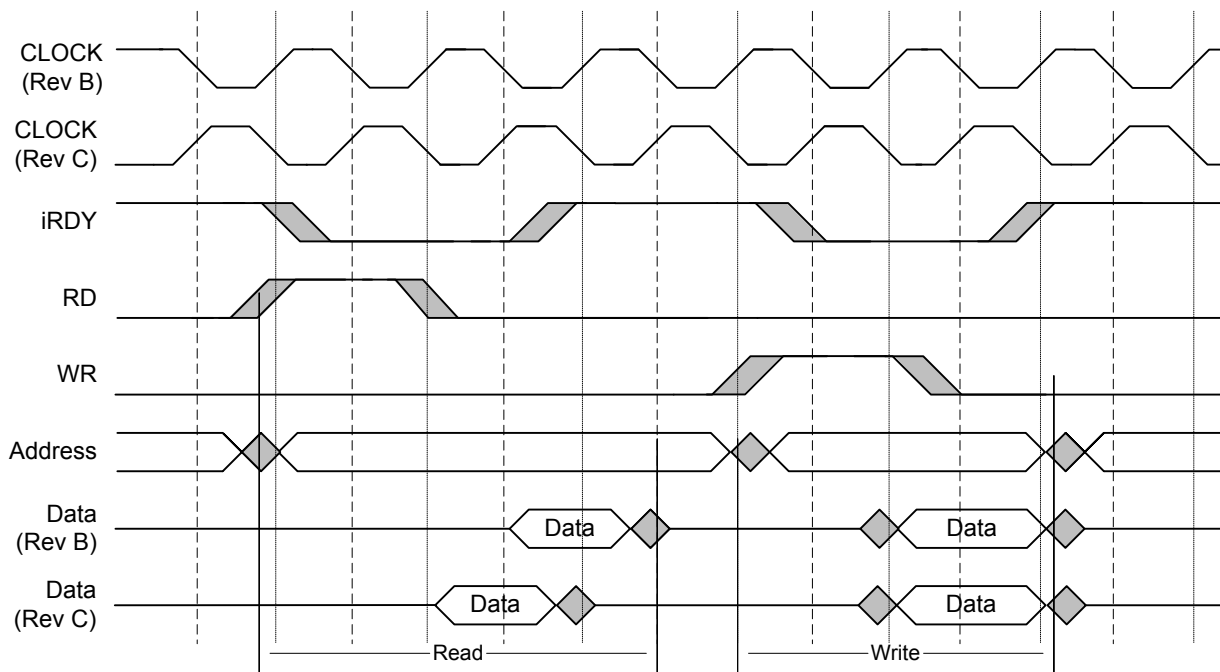
Figure 4. Timing Differences Between Rev B and Rev C Devices

The clock signal that is output on the EPI0S31 signal in General-Purpose mode is inverted. Figure 4 on page 18 shows the timing differences between Rev B parts and Rev C parts.

Use the opposite edge for timing when designing with this interface. During read cycles, ensure that the data meets set up and hold times for the appropriate edge as shown in the diagram above.

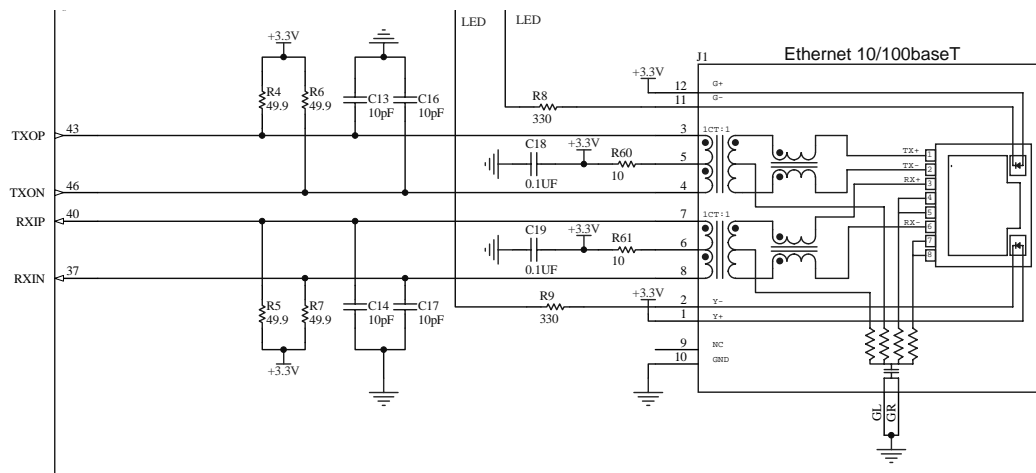
Figure 5. Recommended Center-Tap Connections

The microcontroller experiences some packet loss with Ethernet cables longer than 50 meters in normal operating conditions.

1. Add 10 Ω resistor to the center-tap of the transformer as shown in the figure. These resistors should be replaced by a direct connection for silicon that has this item fixed.
2. Continue using the recommended circuit, but limit cable lengths to 50 meters.

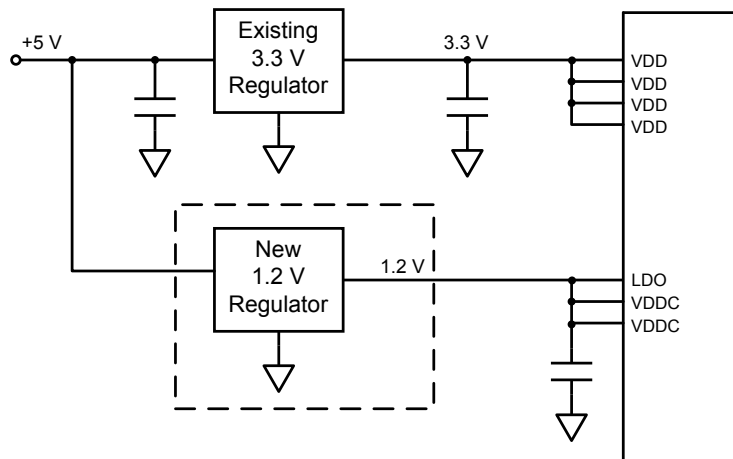
Figure 10. Configuration of External Regulator

Incorrect power sequencing during power up can disrupt operation and potentially cause device failure.

V_{DDC} must be applied approximately 50 μs before V_{DD} . Normally V_{DDC} is controlled by the part's internal LDO voltage regulator. The workaround requires the addition of an external regulator (see Figure 10) to ensure that V_{DDC} sequencing requirements are met (see Figure 11). A recommended regulator is the TI TPS73101DBVR.

This fix mitigates the on-chip power issue, but does not solve it completely. During development, the Flash memory should also be reprogrammed (using LMFlash or another programming tool) at least once a week.
