## Stellaris<sup>®</sup> LM3S9B92 RevC1 Errata

This document contains known errata at the time of publication for the Stellaris LM3S9B92 microcontroller. The table below summarizes the errata and lists the affected revisions. See the data sheet for more details.

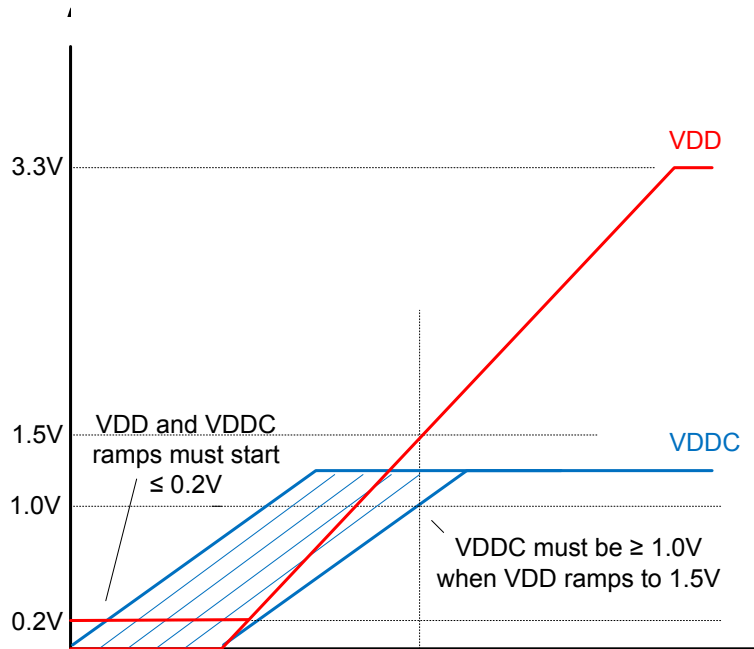
**Figure 1.  $V_{DDC}$  and  $V_{DD}$  Rise Time Relationships**

There is a small risk of flash corruption or device failure on power up. The issue can occur with certain  $V_{DD}$  and  $V_{DDC}$  power sequences. The failure is not in the flash memory itself but in the control logic to the flash.

- The ramp of both  $V_{DD}$  and  $V_{DDC}$  must begin below 0.2 V.
- $V_{DDC}$  must reach at least 1.0 V before  $V_{DD}$  rises above 1.5 V.

Figure 1 on page 9 details these requirements. Three workaround circuits have been identified that meet these requirements and are described below.

To eliminate the risk of flash corruption, two power-on requirements must be met:

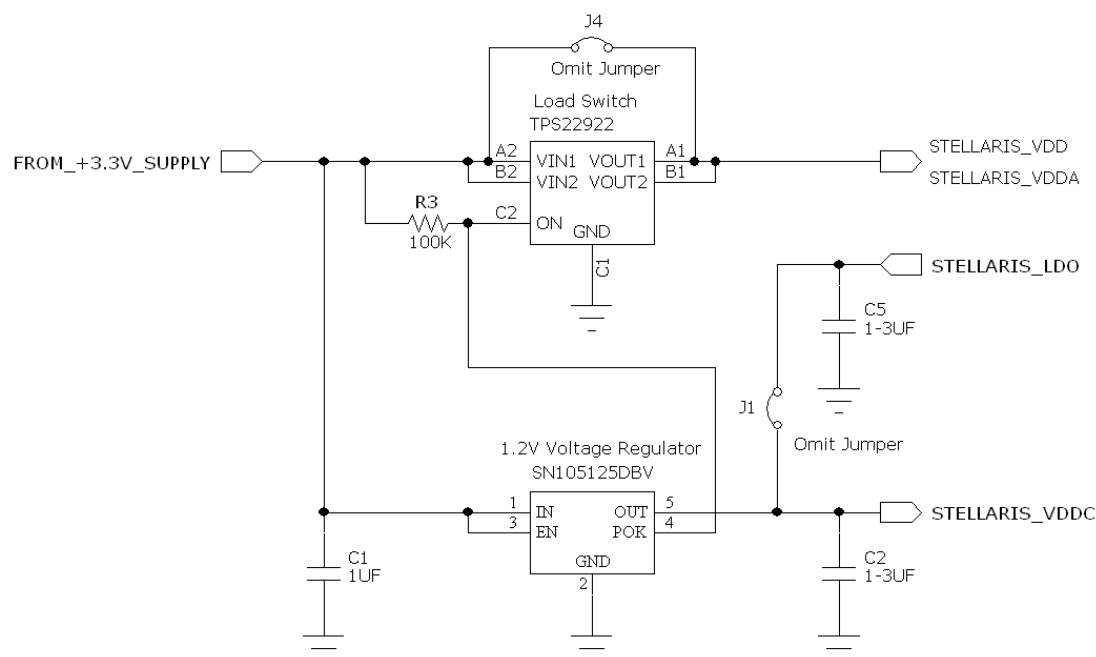
Figure 2 shows a small chip-scale load switch to control  $V_{DD}$ . This circuit is suitable for  $V_{DD}$  current up to 2 A peak.

Three recommended circuits that eliminate the occurrence of this issue are shown below. Although the LDO regulator output is unused in the workaround circuit, a capacitor (1-3  $\mu\text{F}$ ) must remain connected for regulator stability. In addition, the  $\text{LDO}$  pin of the Stellaris device must be disconnected from the external 1.2 V LDO to prevent electronic over stress of the pin. All of these circuits include two jumpers which provide the option to bypass the workaround circuit for future silicon revisions.

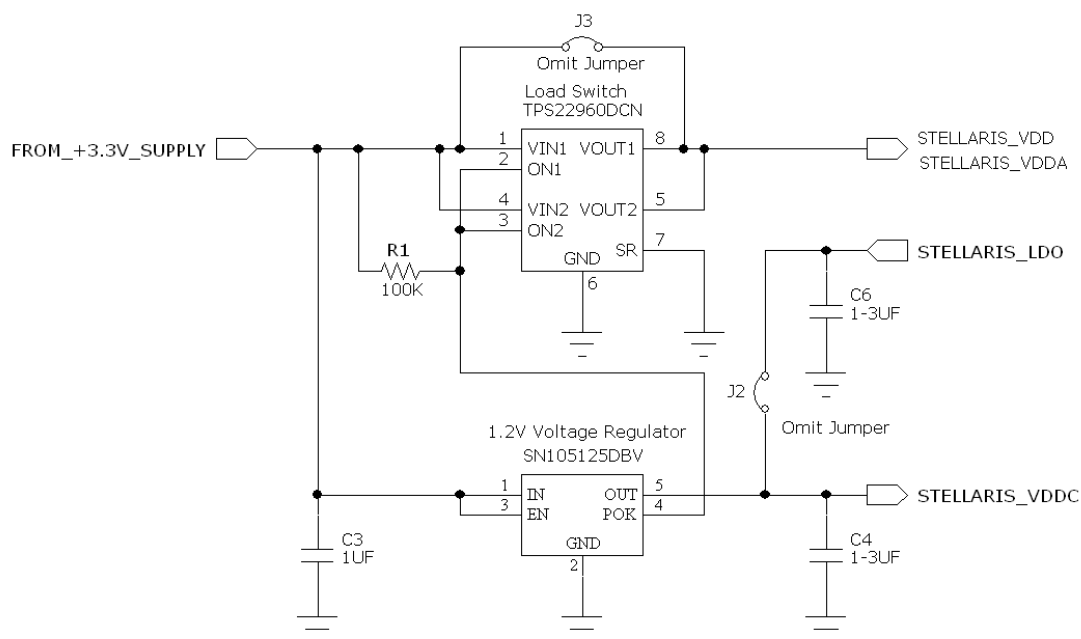
Figure 3 on page 10 shows a larger SOT-packaged load switch with  $V_{DD}$  current capabilities up to 400 mA peak (both channels in parallel).
