Stellaris® LM3S9B92 RevC3/C5 Errata

This document contains known errata at the time of publication for the Stellaris LM3S9B92 microcontroller. The table below summarizes the errata and lists the affected revisions. See the data sheet for more details.

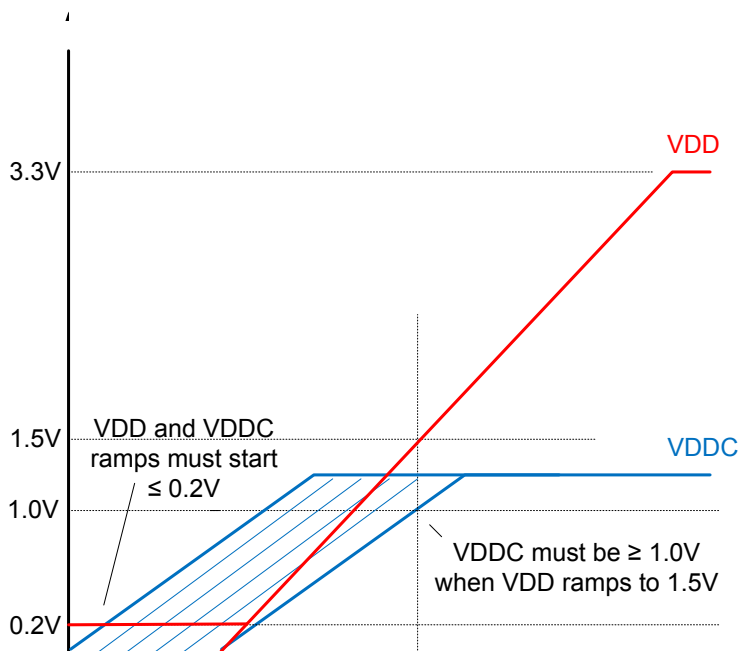
Figure 1. V_{DDC} and V_{DD} Rise Time Relationships

There is a small risk of flash corruption or device failure on power up. The issue can occur with certain V_{DD} and V_{DDC} power sequences. The failure is not in the flash memory itself but in the control logic to the flash.

To eliminate the risk of flash corruption, two power-on requirements must be met:

- The ramp of both V_{DD} and V_{DDC} must begin below 0.2 V.
- V_{DDC} must reach at least 1.0 V before V_{DD} rises above 1.5 V.

Figure 1 on page 10 details these requirements. Three workaround circuits have been identified that meet these requirements and are described below.

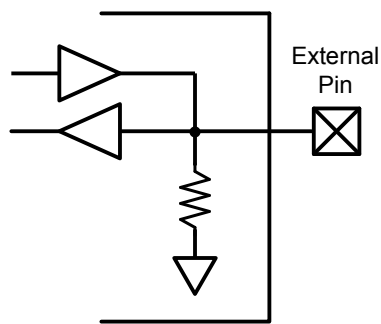
Figure 5. Internal Structure of PB0 and PB1

Regardless of their configuration, PB0 and PB1 have an internal pull-down resistance. The internal structure of these pins is shown in Figure 5 on page 14.

When either of these pins is configured as an input, the external circuit must provide enough drive strength to over-drive the internal pull-down and achieve the necessary V_{IH} voltage level. Analysis is ongoing to determine what value external resistors should have.

When either of these pins is configured as an output, the drive current needed to over-drive the internal pull-down resistance must be subtracted from the drive capabilities of the pin. In some applications, it may be necessary to select a higher drive strength (such as 4 mA instead of 2 mA) to achieve an acceptable output voltage on PB0.
